Mobile Pipe Chosen by California Oil & Gas Producer to Apply Enviroline® 405HT-LV for High Temperature Produced Water

Pipeline Details and Project Summary

Project: Lost Hills Oil Field
Location: Bakersfield, CA
Lining: 15-23 mils of Enviroline®
405HT-LV
Coating: Dual Layer Fusion Bond Epoxy
Substrate: 27,829 LF of 12.75" OD STD
Steel
Contact: Andy Sterling (760) 330-3012
asterling@mobilepipe.net

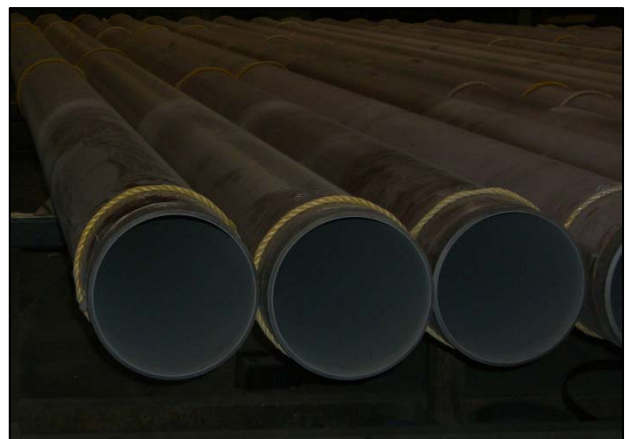
12-inch pipe blasted and ready for the Enviroline® 405HT-LV lining. Pipe was blasted per SSPC SP-5/NACE #1 white metal standard.

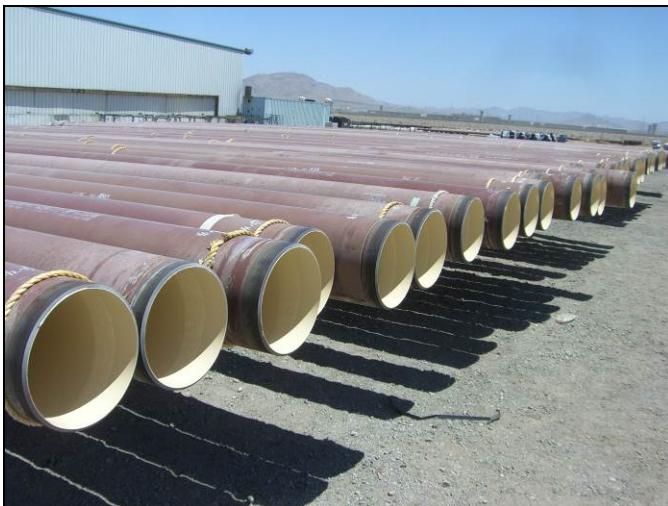
Finished product ready for NACE certified third-party inspection.

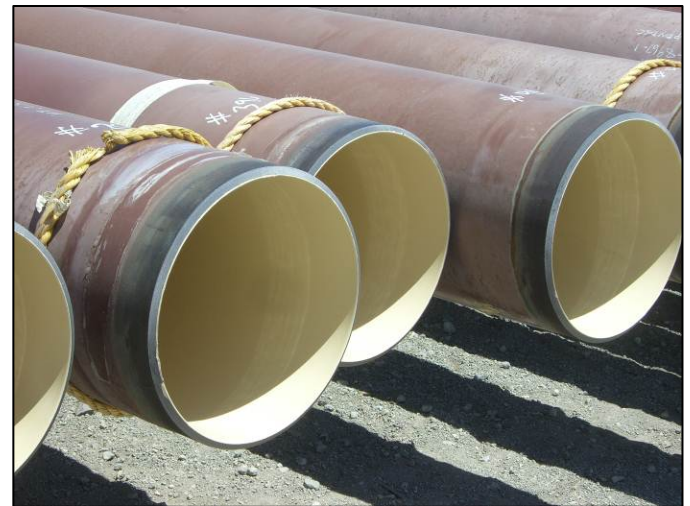
Pipe ready for holiday testing per NACE SPO188-06. In total, 627 joints were tested. Mobile also repaired coating damage to the dual layer FBE to protect the abrasion resistant overlay.

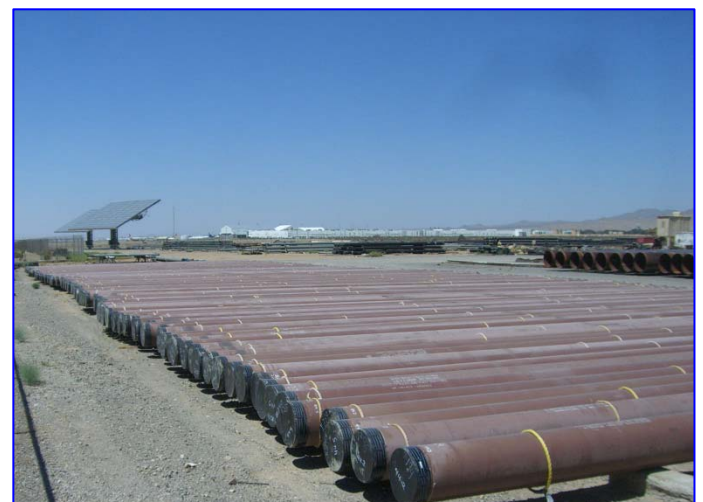
Mobile Pipe stripped and relined over 28,000 LF of steel pipe.
